# The Hedgerow Homeowners' Association, Inc.

November 30, 2023 • Downingtown, PA

RESERVE STUDY

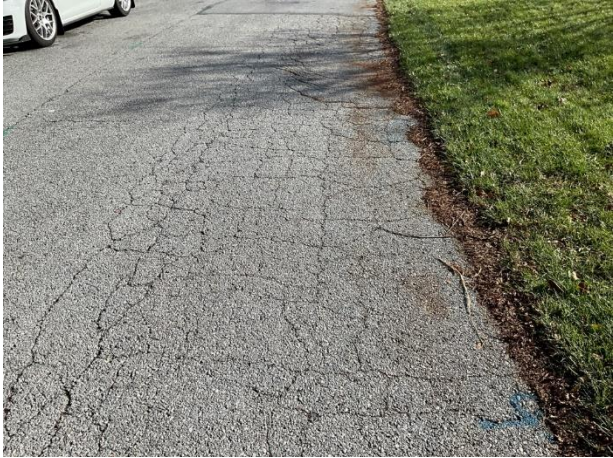
**Condition (continued):** We observe longitudinal, alligator and edge cracks, previous crack and patch repairs, vehicle fluid stains and deterioration at the asphalt pavement.

**Pavement alligator cracks on Suffolk Court**

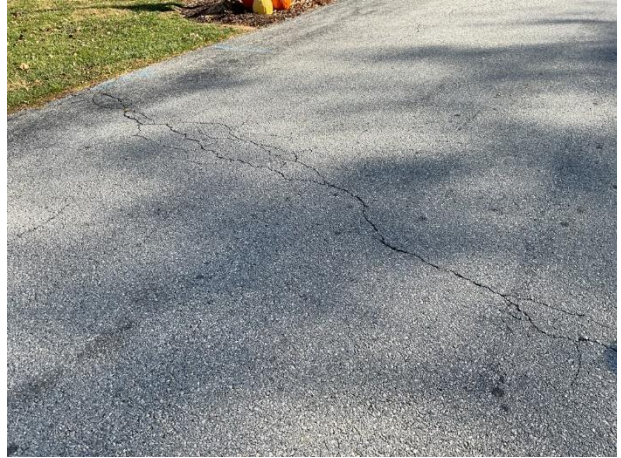
**Pavement cracks on Essex Court**

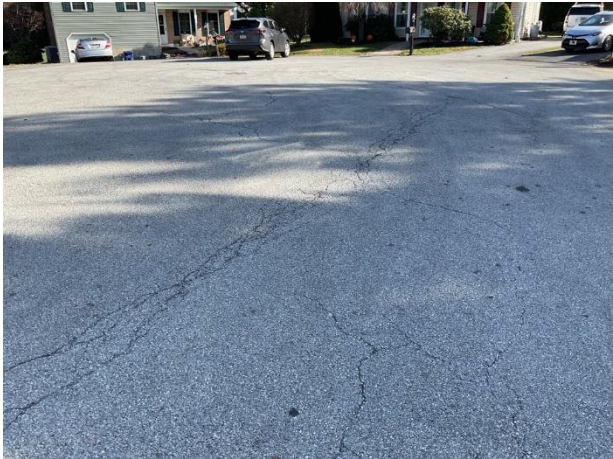
**Pavement cracks on Essex Court**

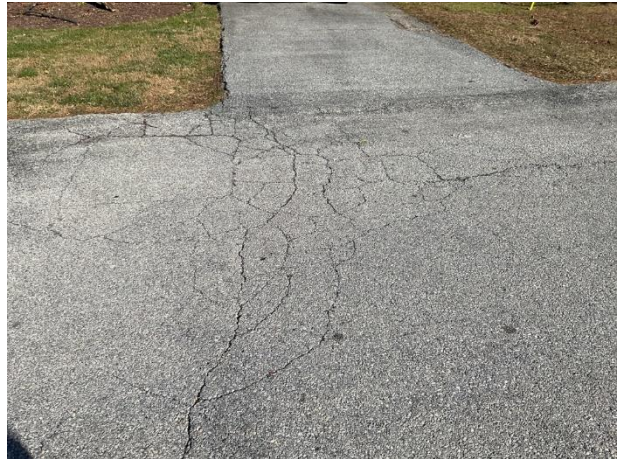
**Alligator and edge cracks on Essex Court**

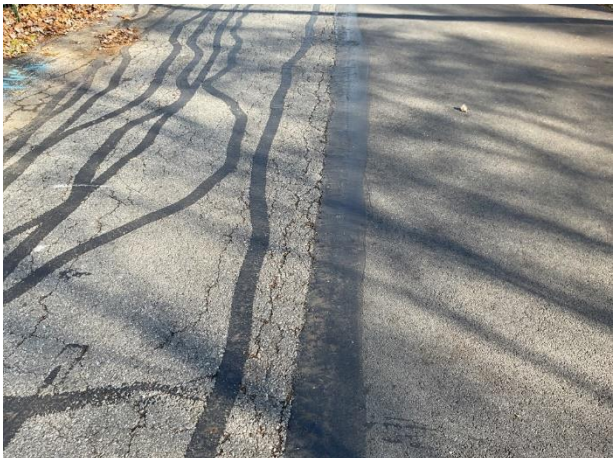
**Pavement cracks on Gloucester court**

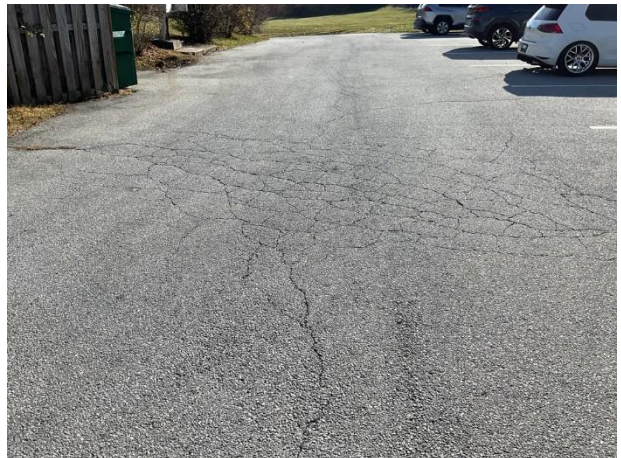
**Alligator cracks on Hastings Court**

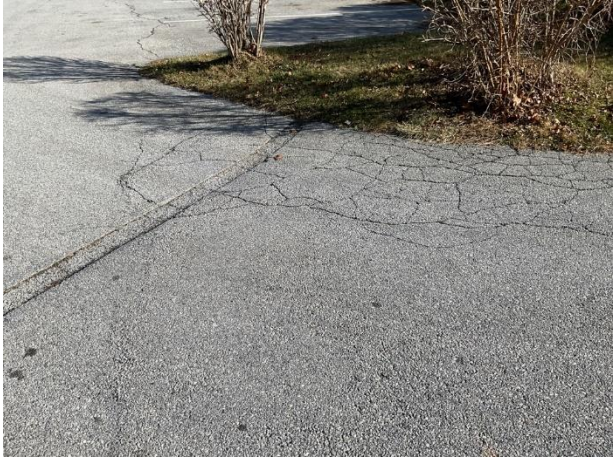
**Pavement cracks on Hastings Court**

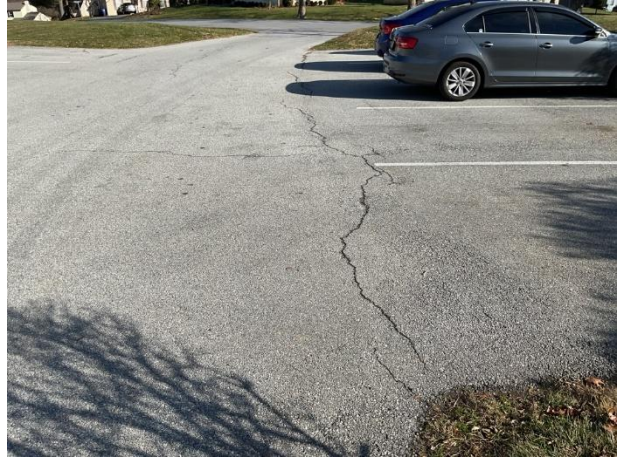
**Longitudinal cracks on Hastings Court**

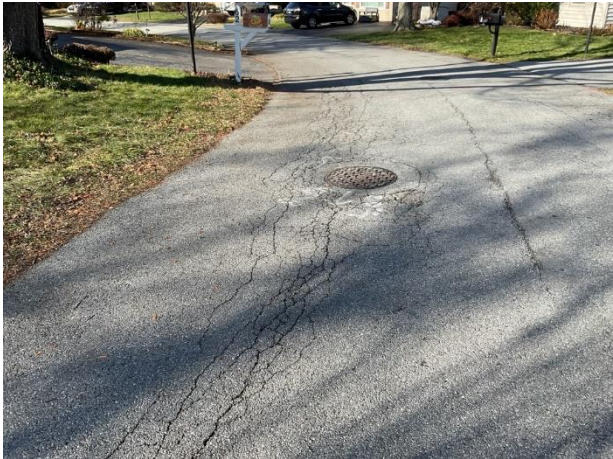
**Alligator cracks on Somerset Court**

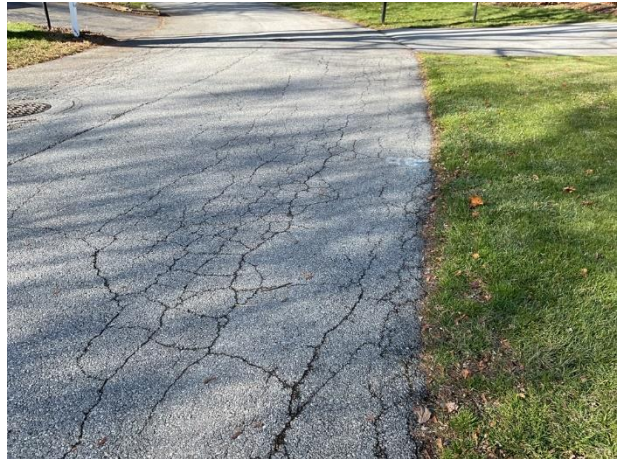
**Alligator and edge cracks on Somerset Court**

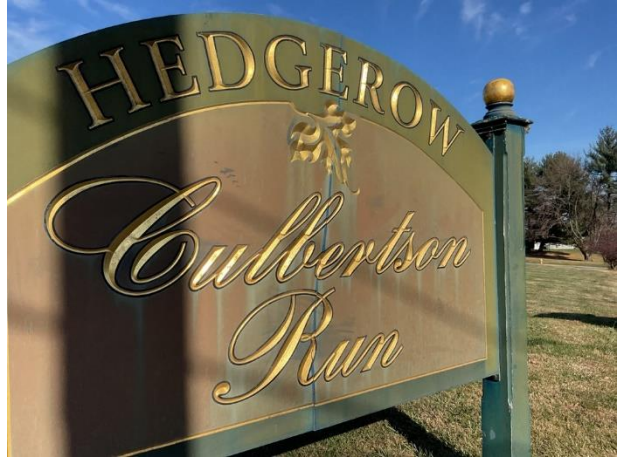
**Signage crack**

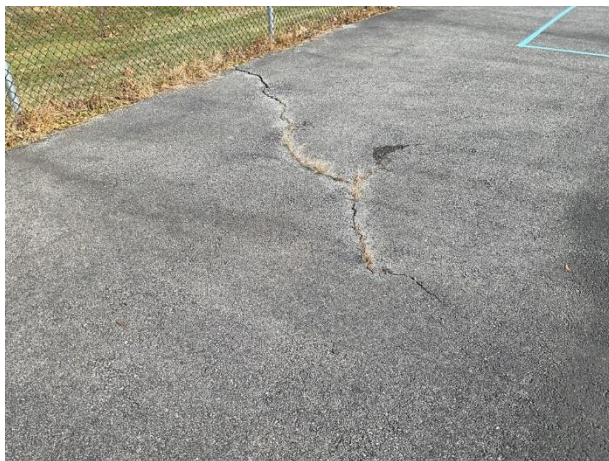
**Condition:** Fair overall condition with cracks, standing water and deterioration evident

**Surface cracks**

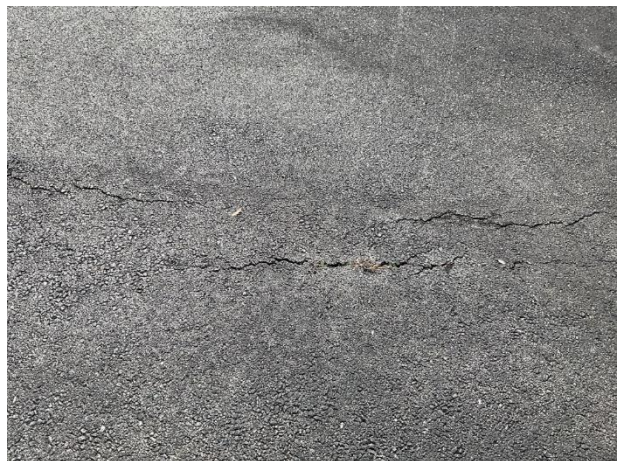
**Surface cracks**

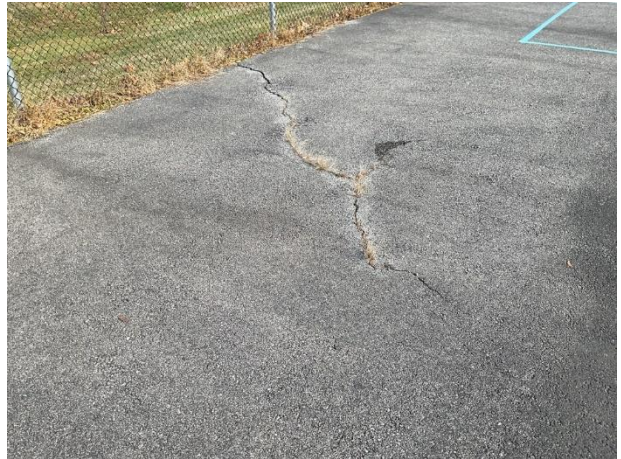
**Condition:** Fair overall condition with cracks and deterioration evident

**Surface cracks**

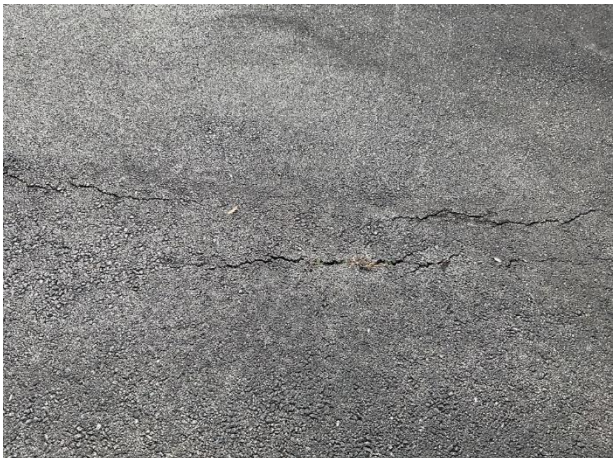
**Surface cracks**

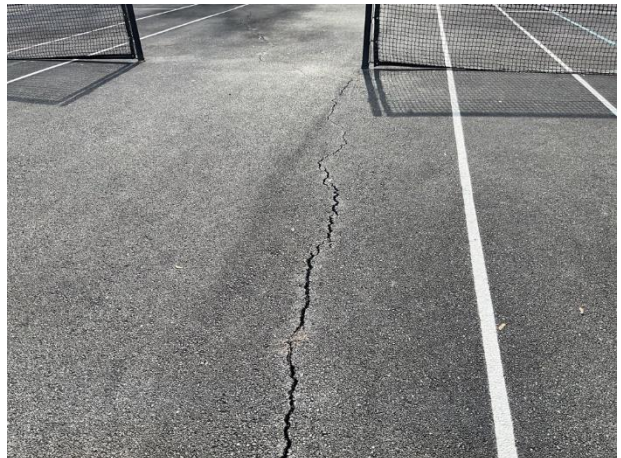
**Surface cracks**

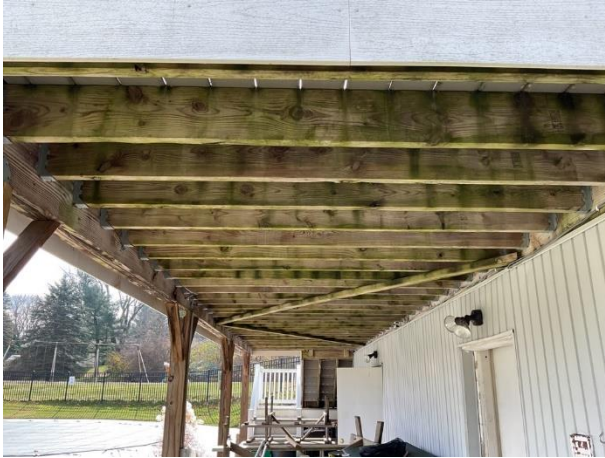
**Condition:** Good to fair overall with organic growth evident

**Balcony overview – We note organic growth**

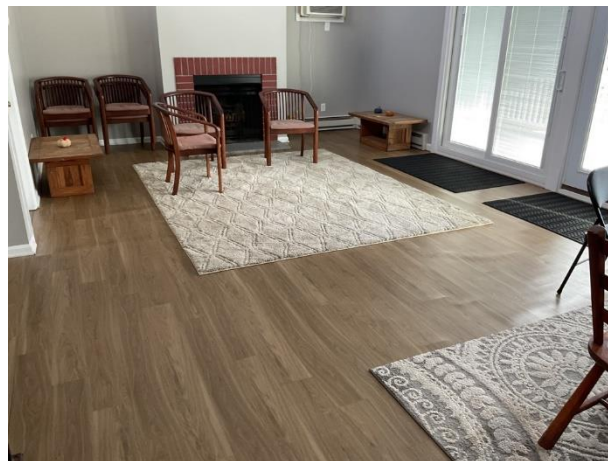
**Condition:** Fair overall condition with bulging and deterioration evident

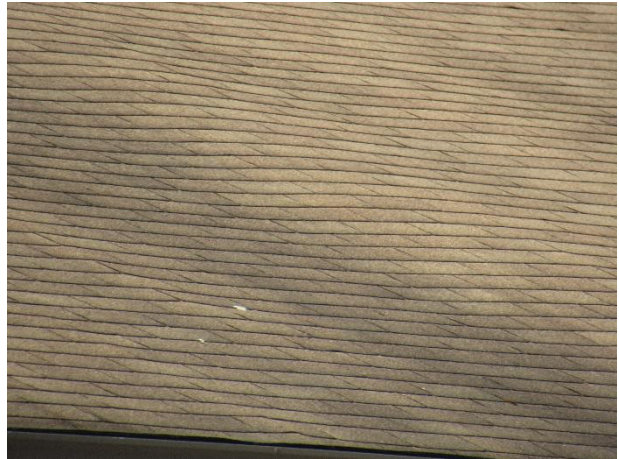
**Condition:** Fair overall condition with stains and sheathing deflection evident from our visual inspection from the ground. Management and the Board does not report a history of leaks.

**Sheathing deflection and stains**

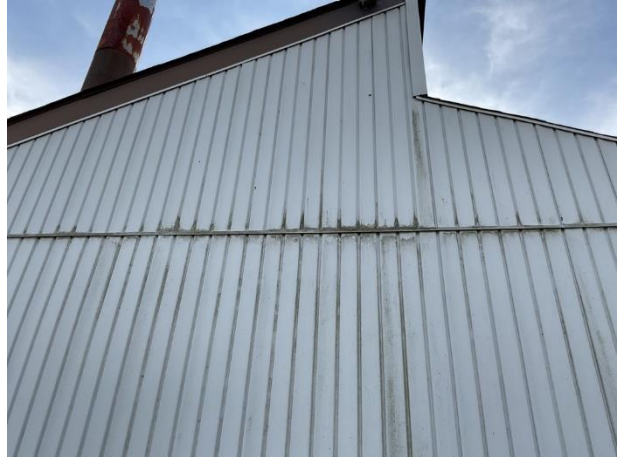
**Condition:** Fair overall condition with previous partial replacements, organic growth and deterioration evident

**Deterioration**

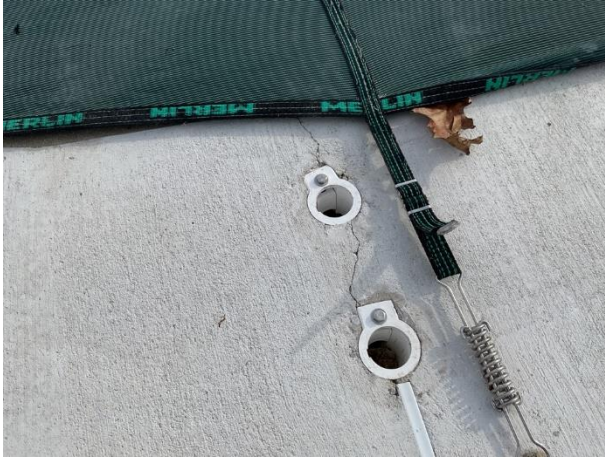
**Condition:** Good to fair overall with cracks evident

**Concrete cracks**

**Useful Life:** We recommend the Association conduct inspections, partial replacements and repairs to the deck every 8- to 12-years.

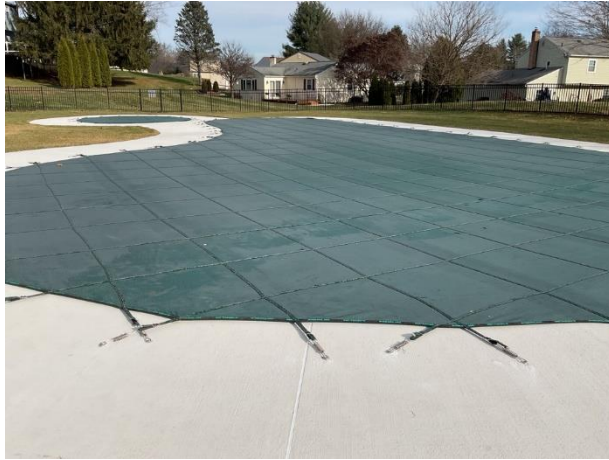
**Condition:** Fair overall with minor tears evident

**Pool cover**

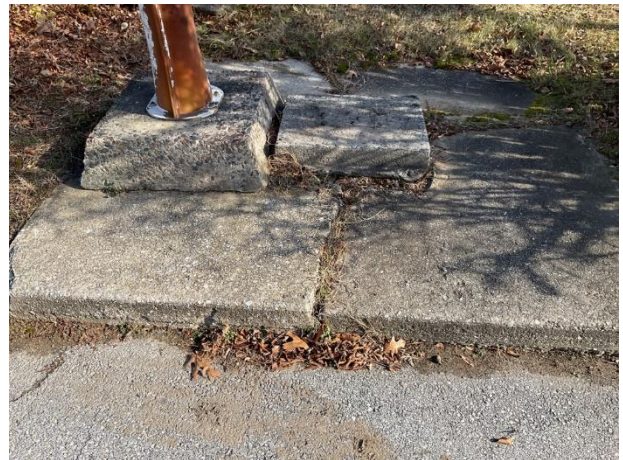
**Condition:** Fair overall with cracks and deterioration evident

**Cracks and deterioration**

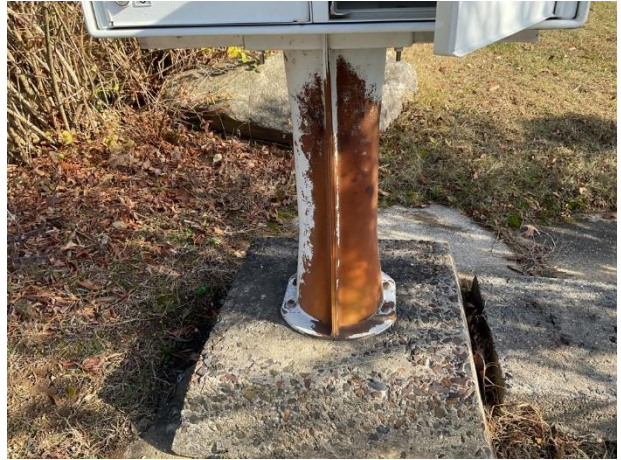
**Condition:** Fair overall with rust and deterioration evident

**Rust and deterioration**
