Hedgerow/Culbertson Run HOA

EAST BRANDYWINE TOWNSHIP, CHESTER COUNTY, PA

stormwater management assessment & recommendations

June 2020

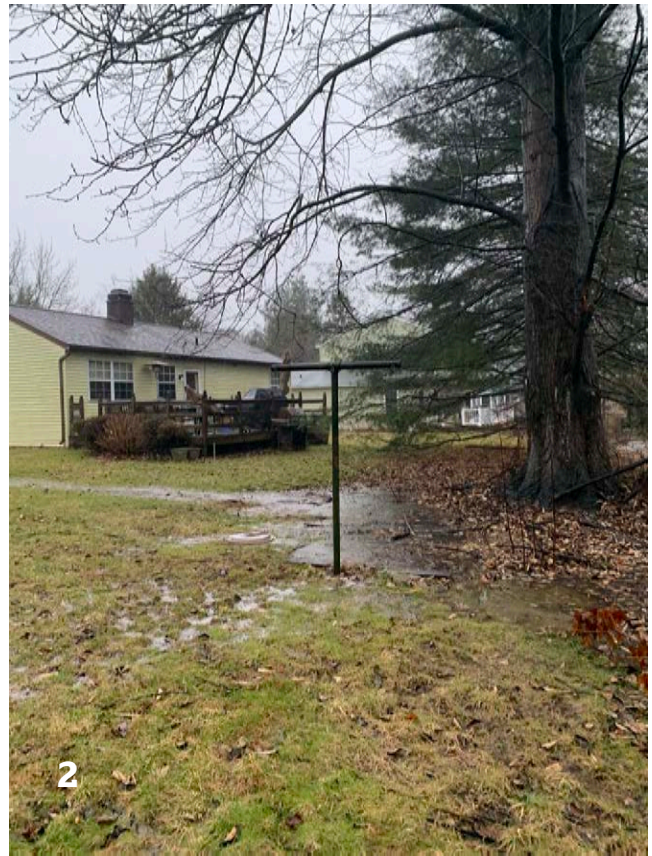
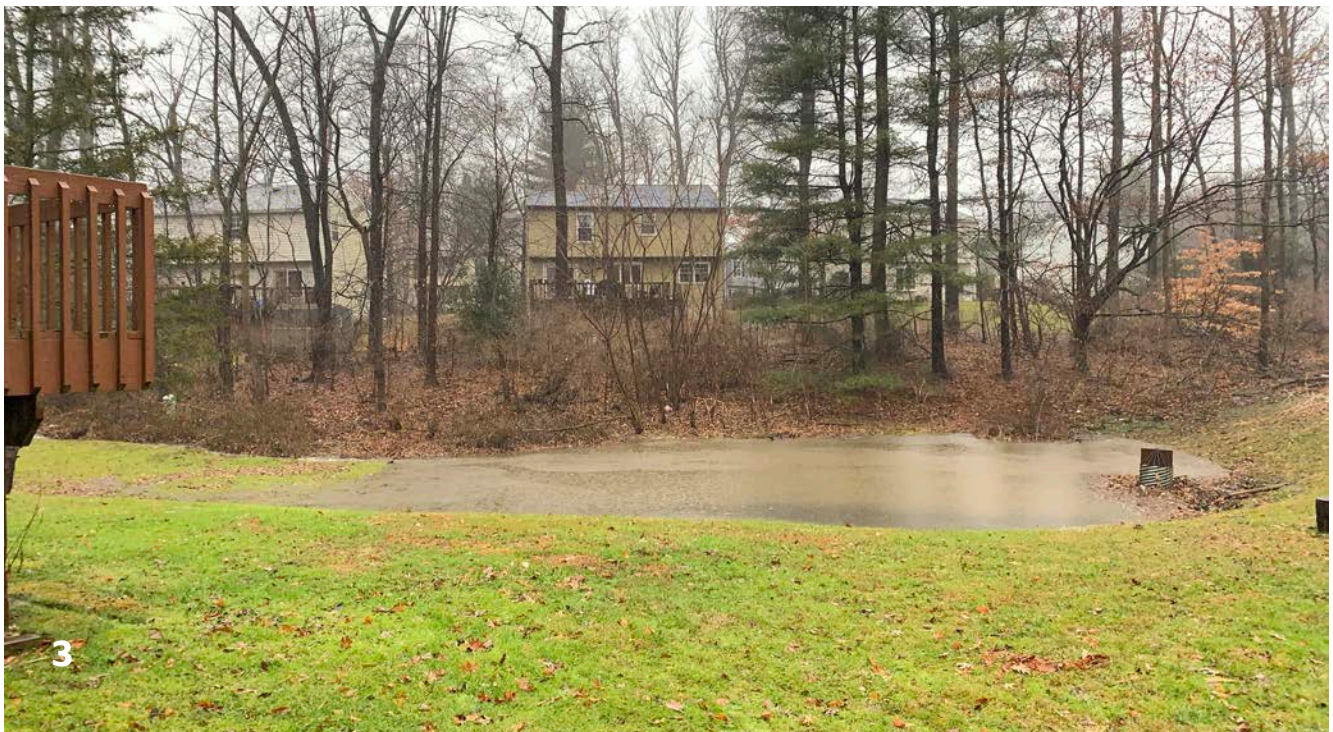
- An existing swale running through the property from Route 322 no longer effectively directs water flow through the HOA site. Water is forming new runnels and channels and saturating the rear yards of individual properties and flooding the existing woodland area at the eastern boundary of the development, **photo 1** and **photo 2**. A non-functioning dry basin adjacent to the far east boundary of the property collects most of this runoff, leading to issues with standing water, saturated soils and insects, **photo 3**. Observation of damp soil and ruts from attempted mowing around and within the basin show evidence of difficulty with ongoing maintenance.

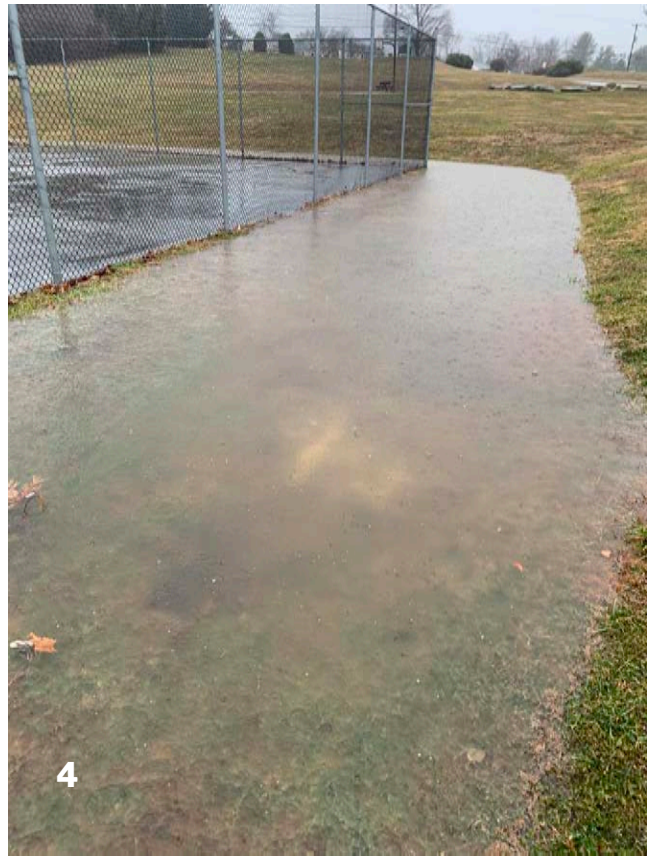
- The lawn area and communal space between Route 322 and the HOA Clubhouse, to the south of the entrance, is underutilized, with drainage issues and standing water adjacent to the tennis courts, **photo 4**.

- **installation of raingardens/raingarden plantings in key areas** – flooding, standing water and saturated soils can be problematic in areas adjacent to the tennis courts and playground. By treating these areas as what they are—natural basins—they can be seen in a different light. Wet areas can be sloped and planted with wetland grasses and perennials, creating areas that are more ornamental, better able to manage and infiltrate stormwater, and are more beneficial to the environment in terms of water purification and wildlife habitat, **photo 16**.

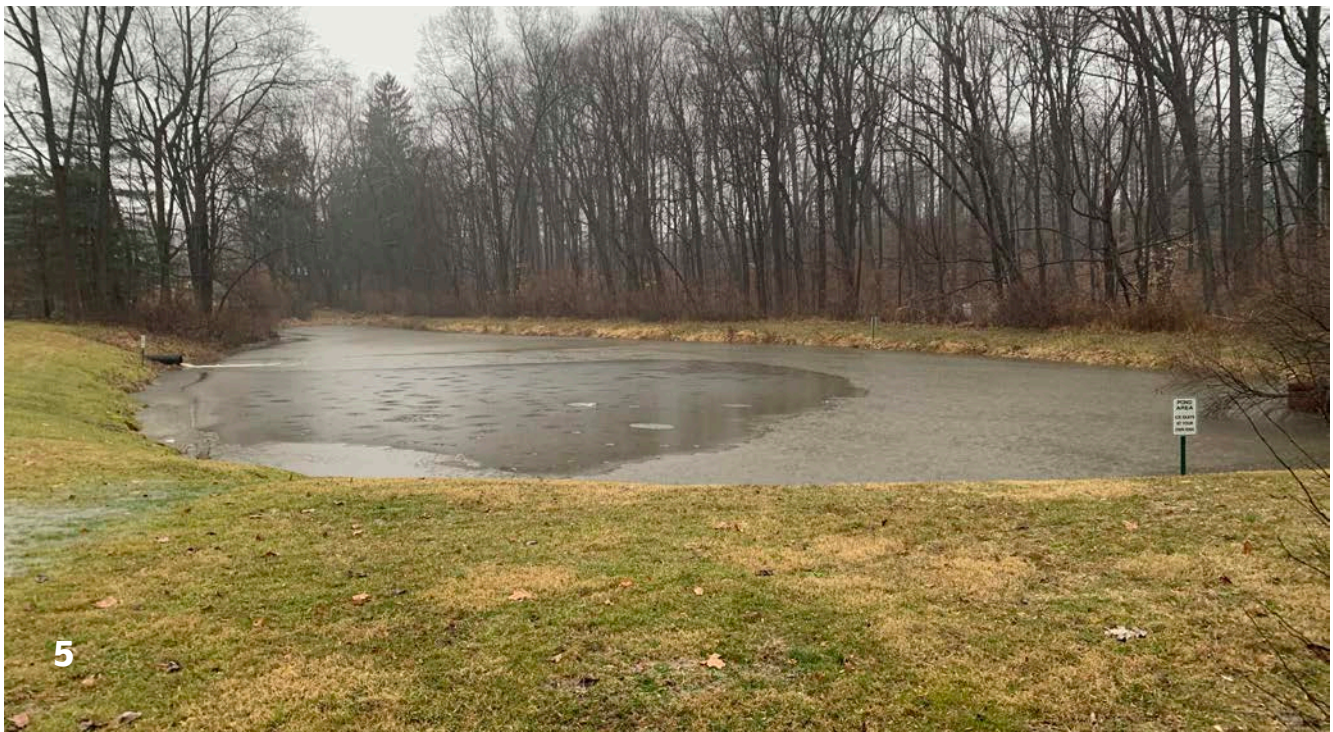
- The Chapel Court Basin to the north end of the property is in need of maintenance, **photo 5**.
- Excess runoff from properties above the Chapel Court Basin contribute to flooding and wet soils around the basin area.

The basin is not functioning as intended. The basin appears inadequate due to sedimentation and lack of ongoing maintenance. Banks are shallow and planted with turf grass, which does little for safety and does little in terms of stormwater management, wildlife habitat or aesthetics, *photo 22*. The following potential solutions are recommended:

- **evaluation of existing basin and structures** – the basin and built features of this basin (outlet, riser, etc.) should be evaluated by a professional and dredged/cleared/unclogged/repared if necessary to ensure functionality (*see Recommended Contractor List*).

- **enlarged basin** – in order to better manage stormwater runoff volume, expanding the basin to the south and planting with native wetland species is recommended.

- **basin and buffer planting** – any area not owned by the adjacent property owner should be converted to a type of landscape better suited to stormwater management. Turf grass can be converted to riparian meadow or forested buffer which is more ecologically beneficial, and better able to slow and infiltrate stormwater flow. The basin banks can be planted with appropriate trees, shrubs and grasses for habitat and stormwater mitigation, and to cut down on need for regular mowing, *photo 23*.

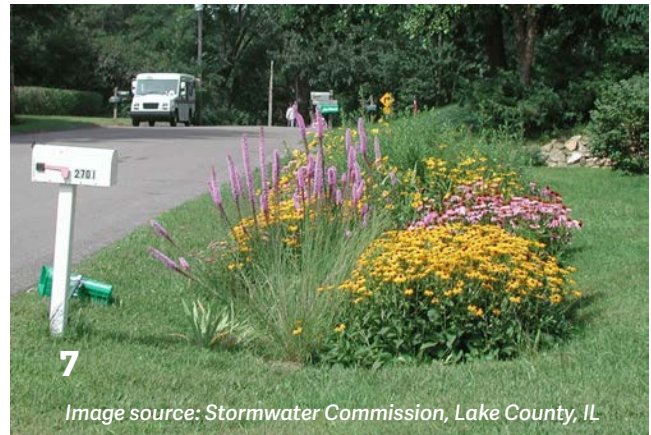
7

bioswales – swaled drainage courses with gently sloped sides filled with vegetation, compost and/or rip-rap, designed to maximize the time water spends in the swale. This aids in the trapping of pollutants and silt from adjacent impervious areas, and encourages infiltration. Landscaping can be designed to be beneficial both aesthetically and ecologically, **photo 7**.

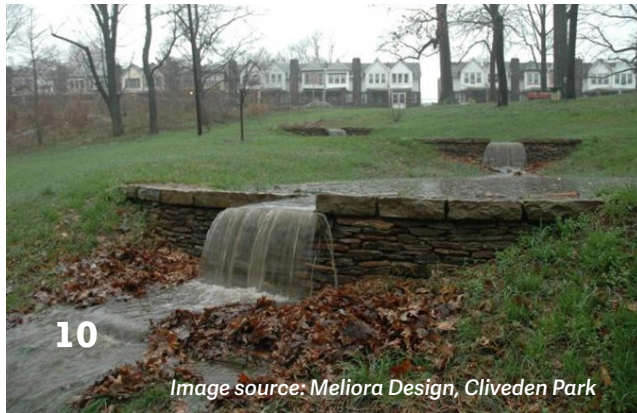
- **installation of weirs** – weirs (ornamental landscape stone or riprap) will allow more space for slowing flow rates and increasing retention and potential infiltration of runoff, reducing the amount and rate of flow downstream, **photo 10**, **photo 11**, and **photo 12**. Ponded areas behind the individual weirs can be landscaped to increase aesthetic and ecological value for the landscape within the development, and also to help manage runoff (*no image available*).

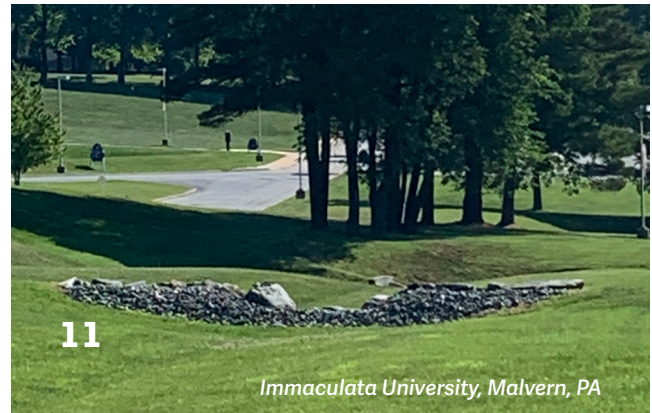
- **native riparian buffer planting** – the existing turf the stormwater runs through and across has no ecological or stormwater management value. Replacing some of the adjacent turf areas with planted native riparian buffers will serve to increase aesthetic and ecological value, as well as provide further ability to treat stormwater runoff, **photo 13**.

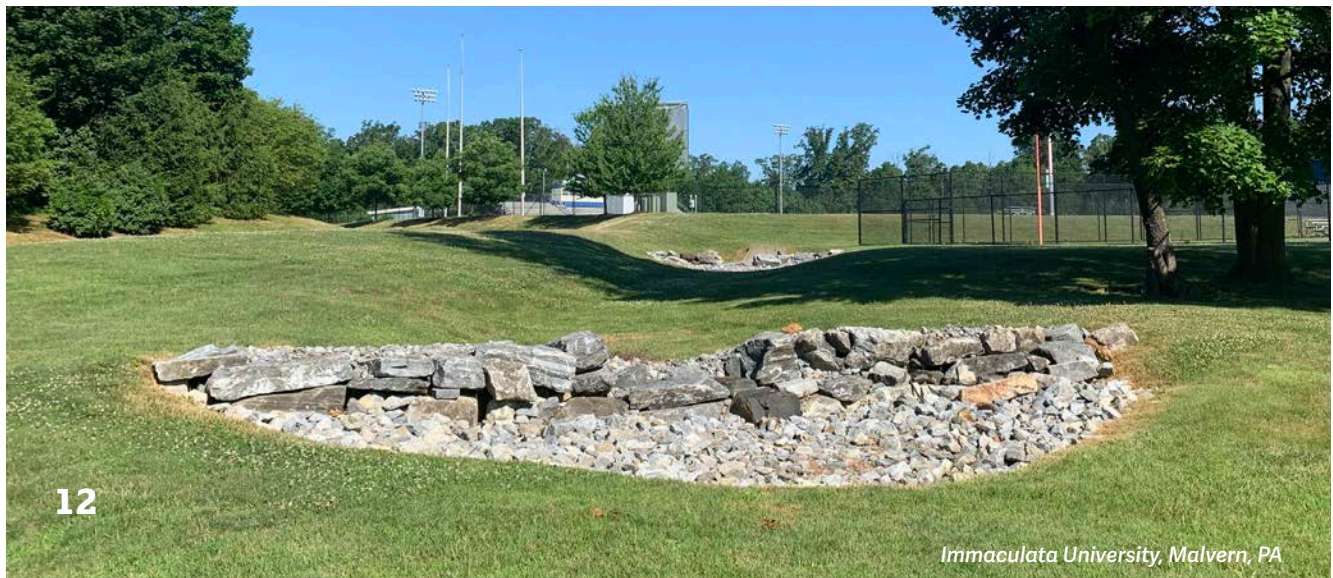
- **expanded swale depth and width** – in addition to weir installations, the swale needs to be widened, with gently sloping banks planted with native riparian shrubs, grasses and trees, **photo 14**.
