FULL RESERVE STUDY

Hedgerow Homeowners Association, Inc.

Downingtown, Pennsylvania September 12, 2017

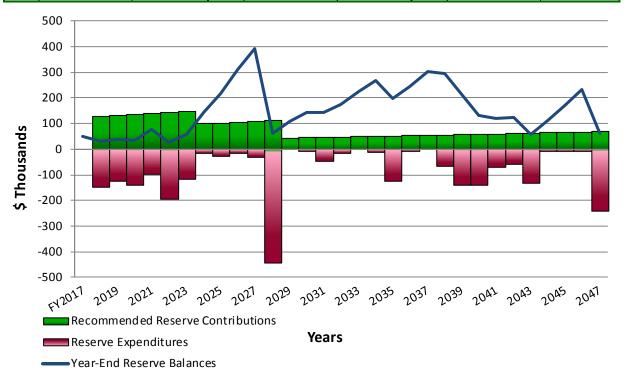
HedgerowRecommended Common Reserve Funding Table and Graph

Reserve	Reserve		Reserve	Reserve		Reserve	Reserve
Year	Contributions (\$)	Balances (\$)	Year	Contributions (\$)	Balances (\$)	Year	Contributions (\$)	Balances (\$)
2018	129,000	32,353	2028	110,400	62,043	2038	54,900	294,324
2019	132,200	39,687	2029	44,000	107,052	2039	56,300	212,586
2020	135,500	33,519	2030	45,100	143,411	2040	57,700	130,035
2021	138,900	76,089	2031	46,200	143,280	2041	59,100	121,508
2022	142,400	25,713	2032	47,400	175,199	2042	60,600	125,704
2023	146,000	56,757	2033	48,600	226,193	2043	62,100	57,539
2024	100,000	143,329	2034	49,800	268,291	2044	63,700	112,171
2025	102,500	218,808	2035	51,000	198,159	2045	65,300	171,175
2026	105,100	310,832	2036	52,300	244,828	2046	66,900	233,119
2027	107,700	392,646	2037	53,600	301,688	2047	68,600	62,978

- Increase to \$129,000 in 2018
- Inflationary increases from 2019 through 2023
- Decrease to \$100,000 by 2024 due to fully funding for asphalt repaving
- Inflationary increases from 2025 through 2028
- Decrease to \$44,000 by 2029 due to fully funding for replacement of the pool structures and deck
- Inflationary increases through 2047, the limit of this study's Cash Flow Analysis

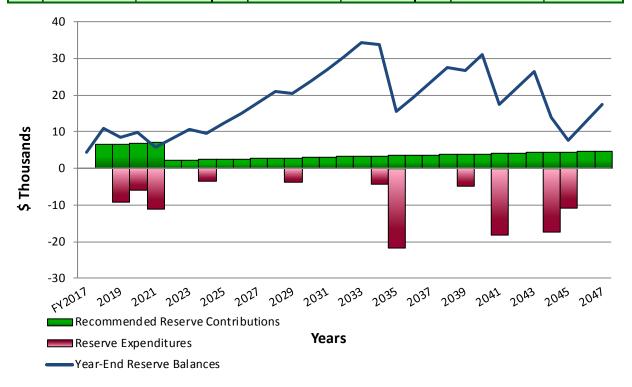
HedgerowRecommended Townhome Reserve Funding Table and Graph

Reserve	Reserve		Reserve	Reserve		Reserve	Reserve
Year	Contributions (\$)	Balances (\$)	Year	Contributions (\$)	Balances (\$)	Year	Contributions (\$)	Balances (\$)
2018	6,500	11,014	2028	2,800	21,037	2038	3,800	27,542
2019	6,700	8,533	2029	2,900	20,351	2039	3,900	26,860
2020	6,900	9,727	2030	3,000	23,613	2040	4,000	31,206
2021	7,100	5,882	2031	3,100	27,015	2041	4,100	17,510
2022	2,200	8,166	2032	3,200	30,558	2042	4,200	21,945
2023	2,300	10,578	2033	3,300	34,244	2043	4,300	26,534
2024	2,400	9,711	2034	3,400	33,712	2044	4,400	13,937
2025	2,500	12,343	2035	3,500	15,672	2045	4,500	7,786
2026	2,600	15,107	2036	3,600	19,482	2046	4,600	12,507
2027	2,700	18,004	2037	3,700	23,438	2047	4,700	17,385

- Increase to \$6,500 in 2018
- Inflationary increases from 2019 through 2021
- Decrease to \$2,200 by 2022 due to fully funding for replacement of the fences at the trash corrals
- Inflationary increases through 2047, the limit of this study's Cash Flow Analysis

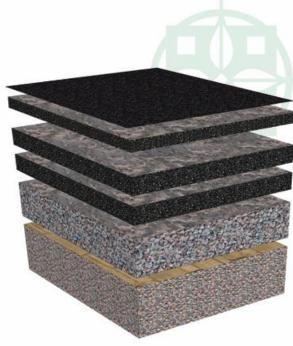
ASPHALT DIAGRAM

Component Detail Notes: The initial installation of asphalt uses at least two lifts, or two separate applications of asphalt, over the base course. The first lift is the binder course. The second lift is the wearing course. The wearing course comprises a finer aggregate for a smoother more watertight finish. The following diagram depicts the typical components although it may not reflect the actual configuration at Hedgerow:

Sealcoat or Wearing Surface
Asphalt Overlay Not to Exceed
1.5 inch Thickness per Lift or Layer

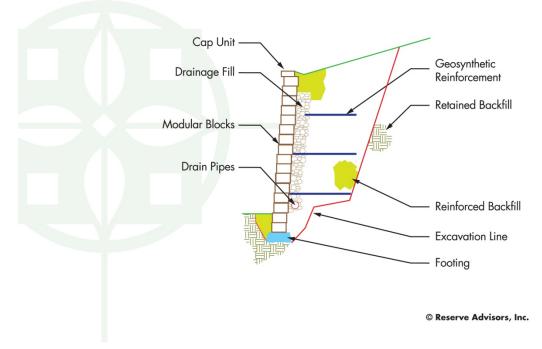
MASONRY RETAINING WALL DETAIL

Component Detail Notes: We advise Hedgerow replace with a modular, interlocking dry-set masonry retaining wall system. The cost of dry-set masonry retaining walls is similar to the cost of timber walls. However, dry-set masonry retaining walls offer a longer useful life of up to 35 years and lower total maintenance costs. The following schematic depicts the typical components of a retaining wall system although it may not reflect the actual configuration at Hedgerow:

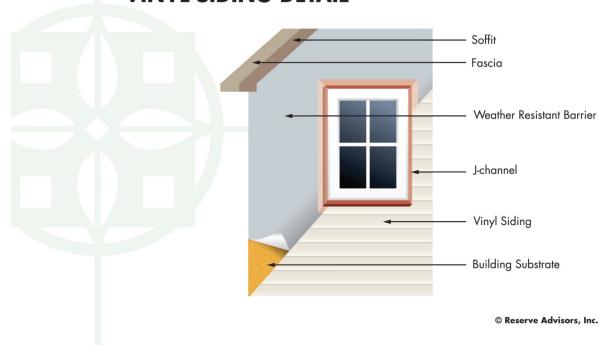
VINYL SIDING DETAIL

vinyl siding system:
