# The Hedgerow Homeowners' Association, Inc.

November 30, 2023 • Downingtown, PA

RESERVE STUDY

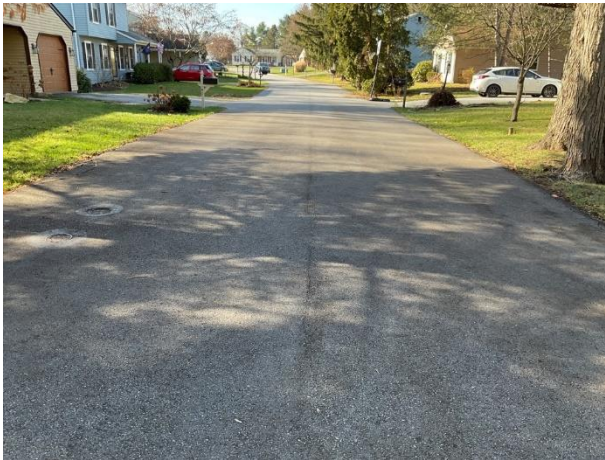
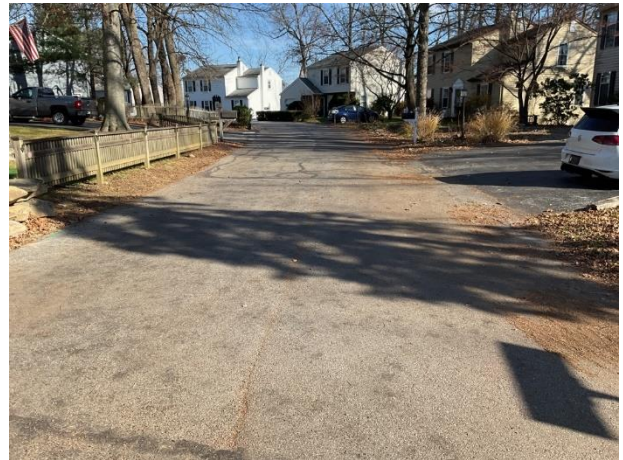
**Condition (continued):** We observe longitudinal, alligator and edge cracks, previous crack and patch repairs, vehicle fluid stains and deterioration at the asphalt pavement.

Typical asphalt pavement overview

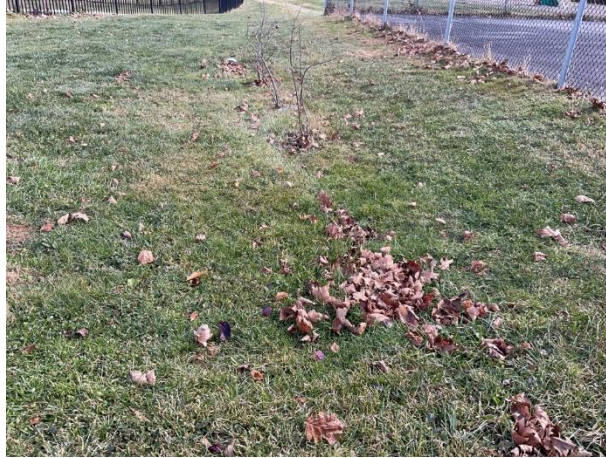
**Condition:** Good to fair condition

**Drainage swale overview**

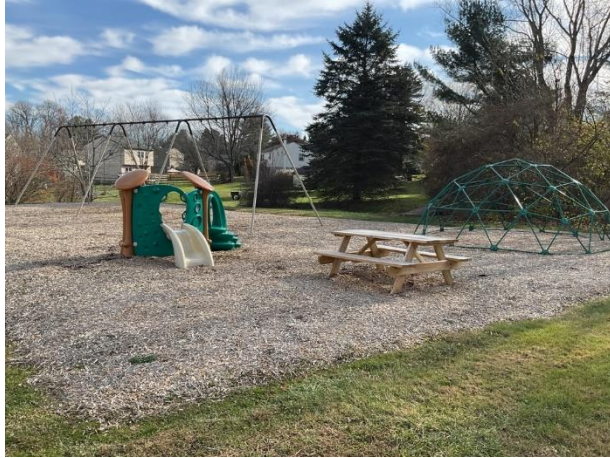
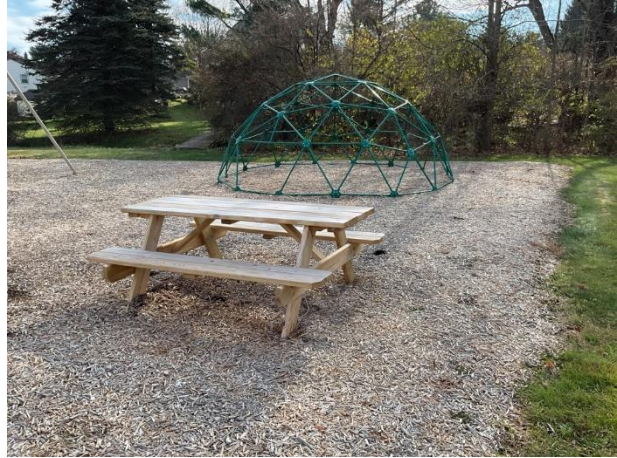
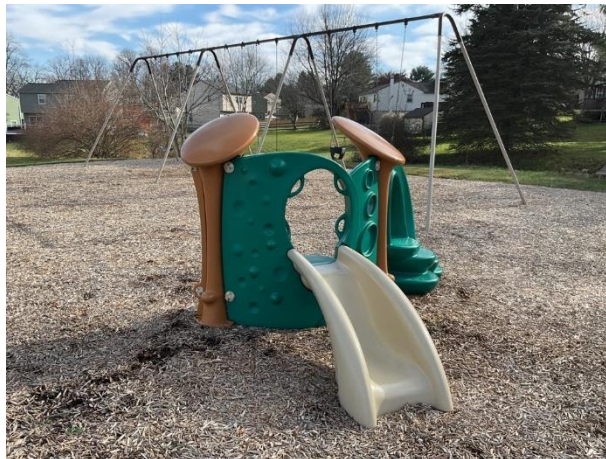
**Condition:** Good to fair overall

**Playground equipment**

**Jungle gym overview**

**Playset overview**

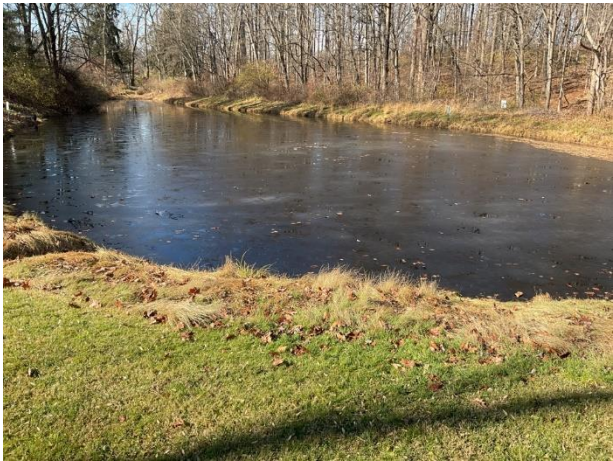
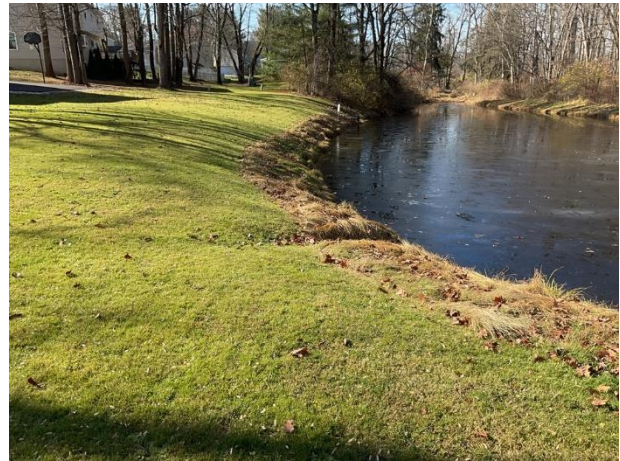
**Condition:** Good to fair overall

**Pond overview**

**Shoreline overview**

**Useful Life:** Based on the visual condition, construction, adjacent deciduous trees and visibly apparent erosion, we recommend the Association anticipate the need to remove pond sediment up to every 30 years.

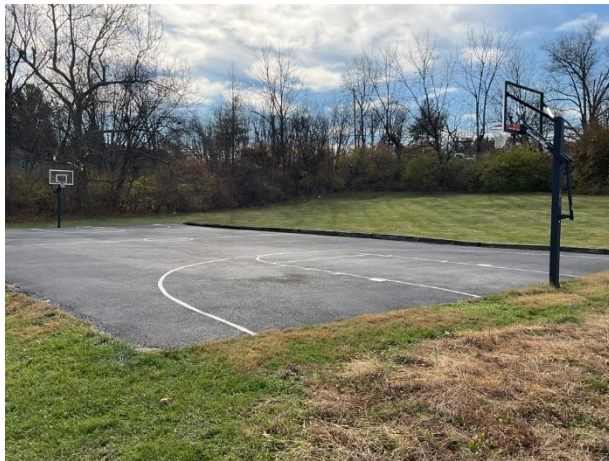
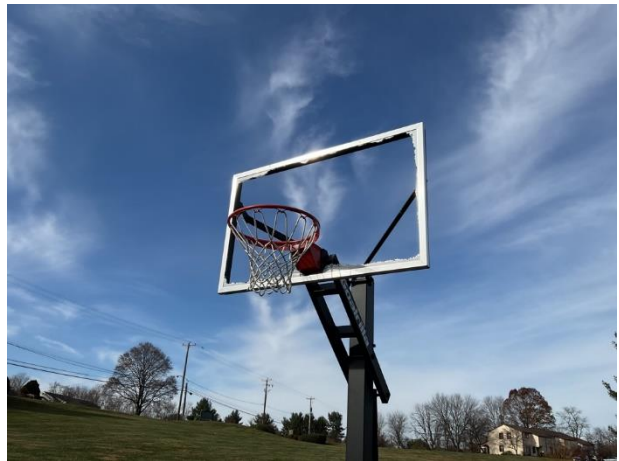
**Condition:** Fair overall condition with cracks, standing water and deterioration evident

**Basketball court overview**

**Shattered backboard**

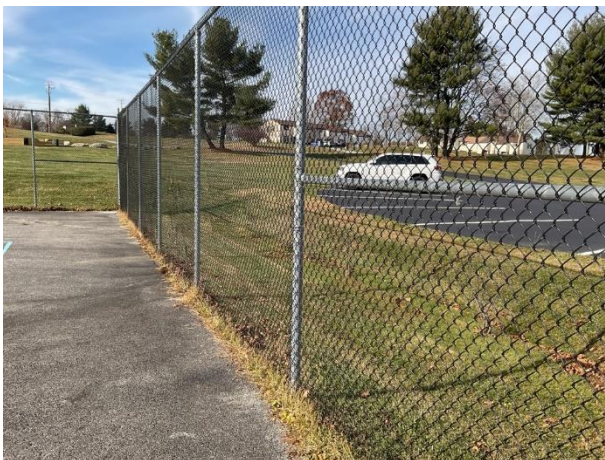
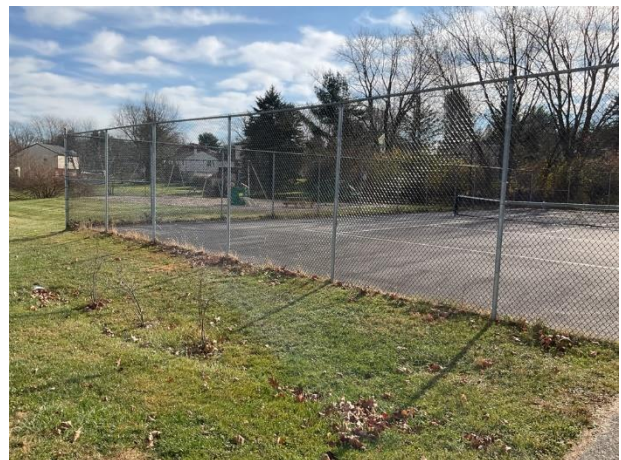
**Condition:** Good overall condition with no significant deterioration evident

**Chain link fence**

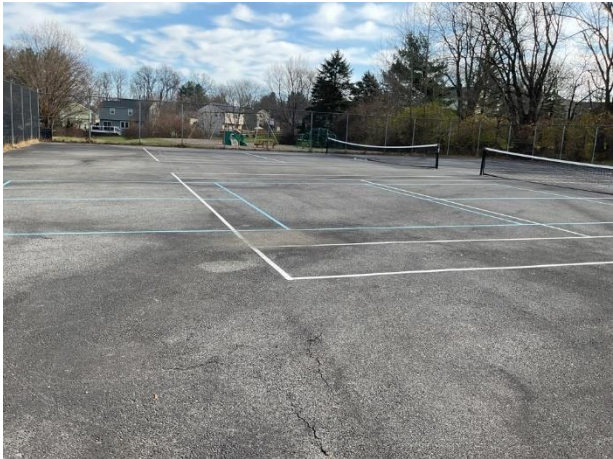
**Condition:** Fair overall condition with cracks and deterioration evident

**Tennis court overview**

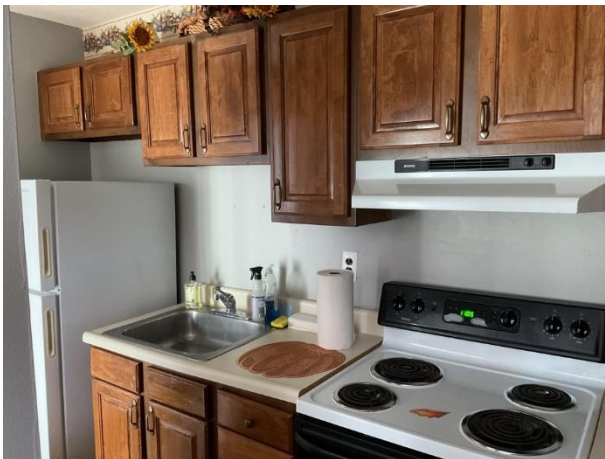
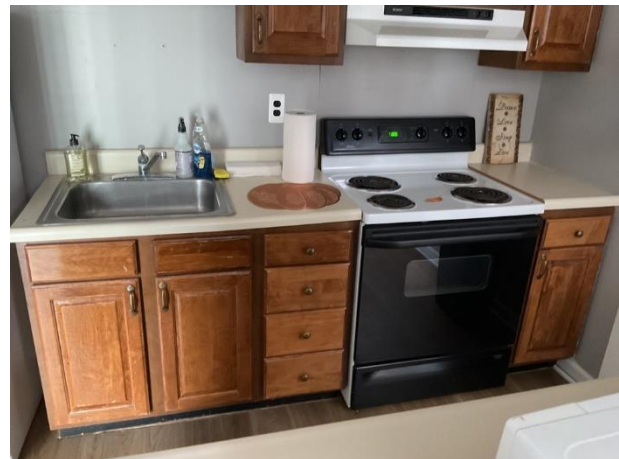
**Condition:** Fair overall condition with minor deterioration evident

Kitchen overview

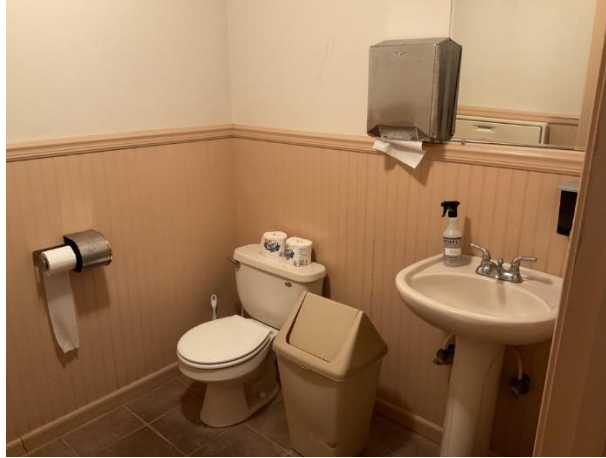
**Condition:** Fair overall condition with minor deterioration evident

**Rest room overview**

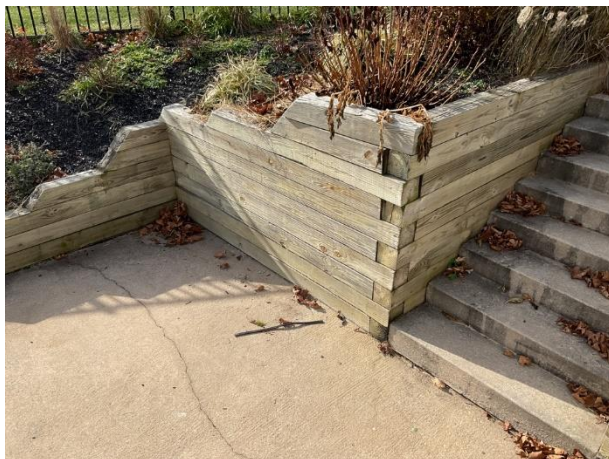
**Condition:** Fair overall condition with minor deterioration evident

**Timber retaining wall**

**Leaning section**

**Component Detail Notes:** We advise The Hedgerow replace with a modular, interlocking dry-set masonry retaining wall system. The cost of dry-set masonry retaining walls is similar to the cost of timber walls. However, dry-set masonry retaining walls offer a longer useful life of up to 35 years and lower total maintenance costs. The following schematic depicts the typical components of a retaining wall system although it may not reflect the actual configuration at The Hedgerow:

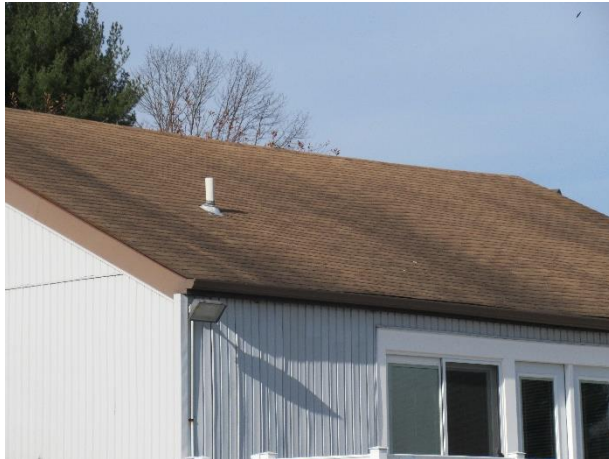
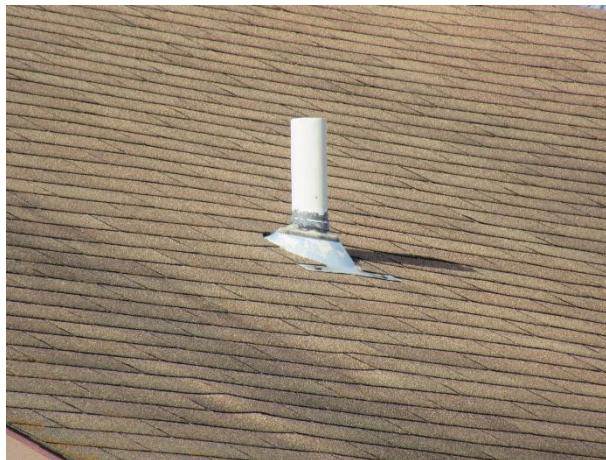
**Condition:** Fair overall condition with stains and sheathing deflection evident from our visual inspection from the ground. Management and the Board does not report a history of leaks.

**Roof overview**

**Waste pipe with metal boot**

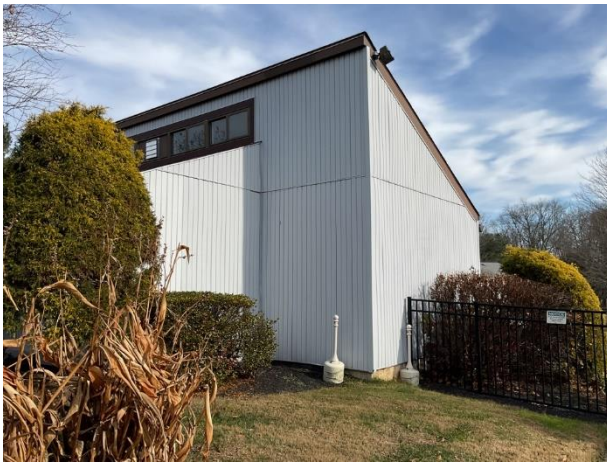
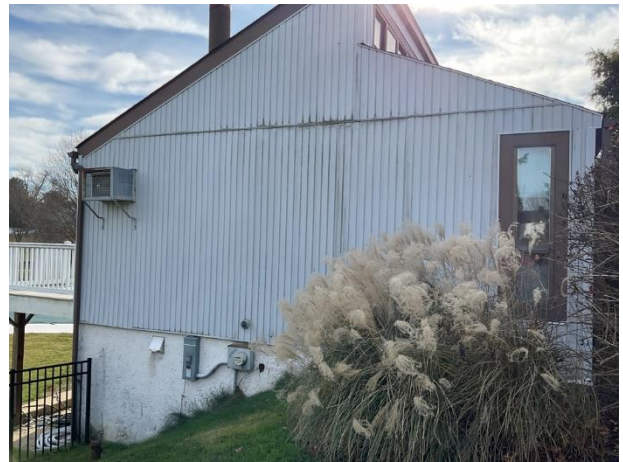
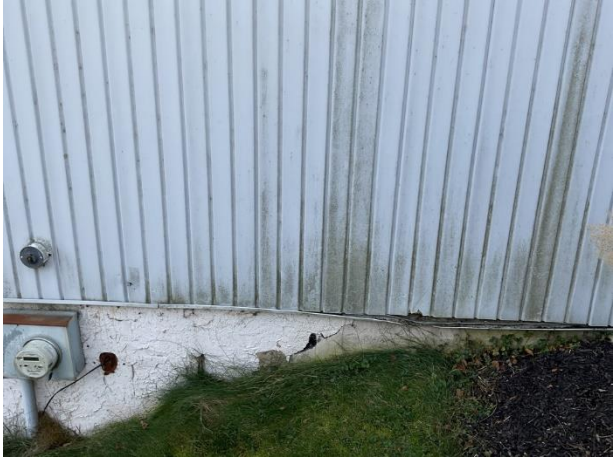
**Condition:** Fair overall condition with previous partial replacements, organic growth and deterioration evident

Vinyl siding overview

**Organic growth**

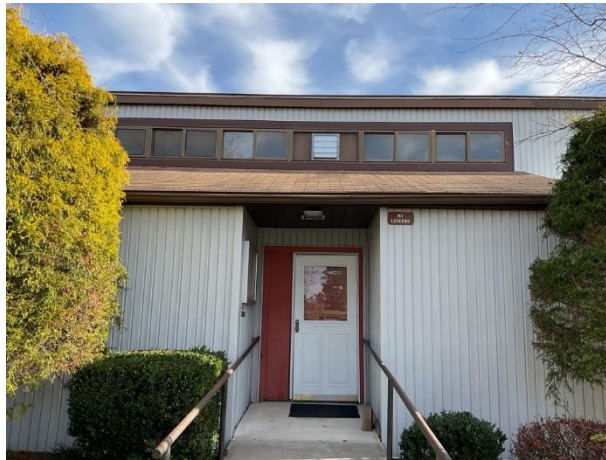
**Condition:** Fair overall condition with deterioration evident

**Common windows and doors**

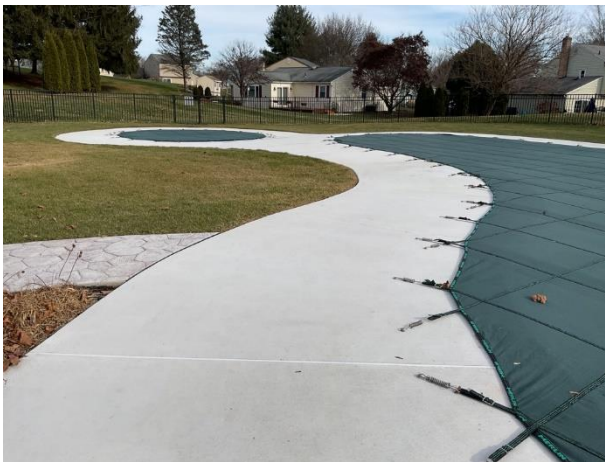
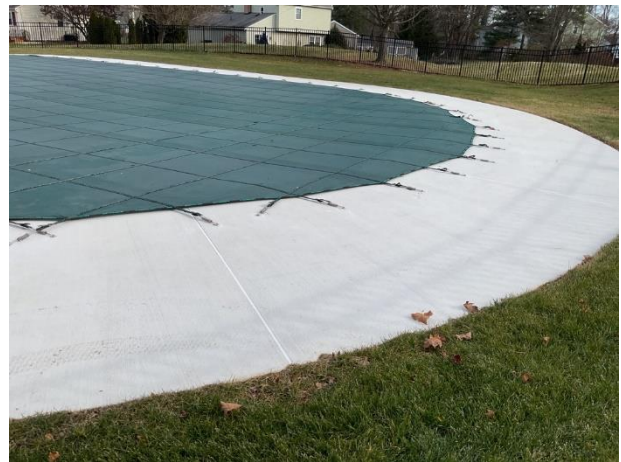
**History:** The Board informs us of concrete deck repairs in 2023 due to the pool structure heaving.

**Condition:** Good to fair overall with cracks evident

Concrete pool deck overview

- Selective cut out and replacements of up to ten percent (10%) of concrete
- Crack repairs as needed
- Mortar joint repairs
- Caulk replacement
- Coating replacement

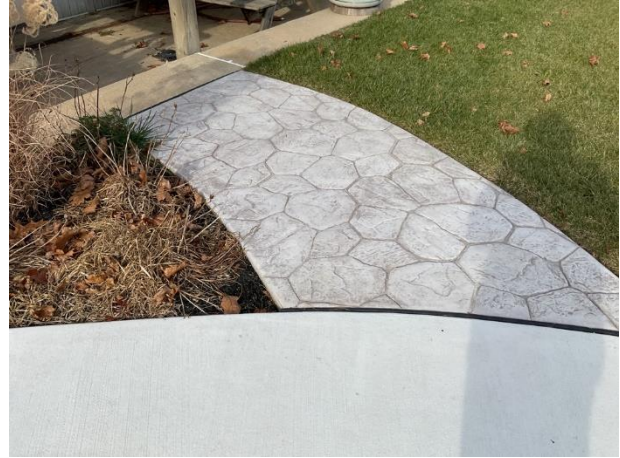
**Stamped concrete overview**

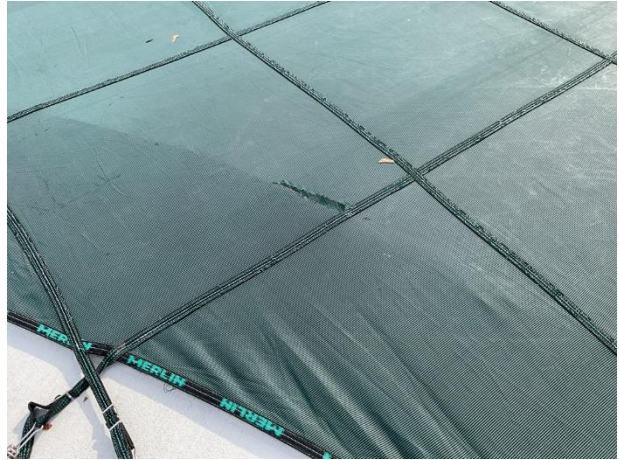
**Condition:** Fair overall with minor tears evident

**Vinyl cover tear**

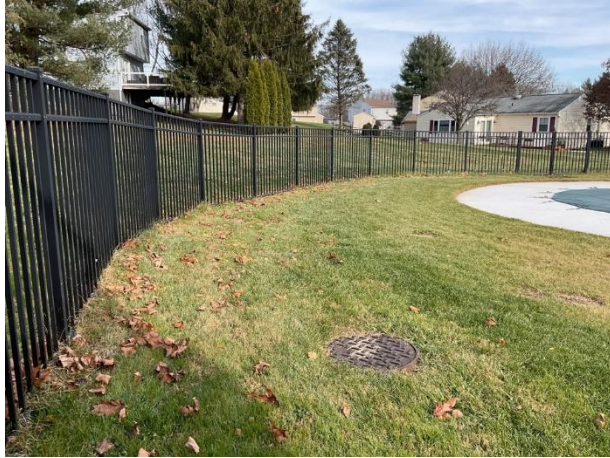
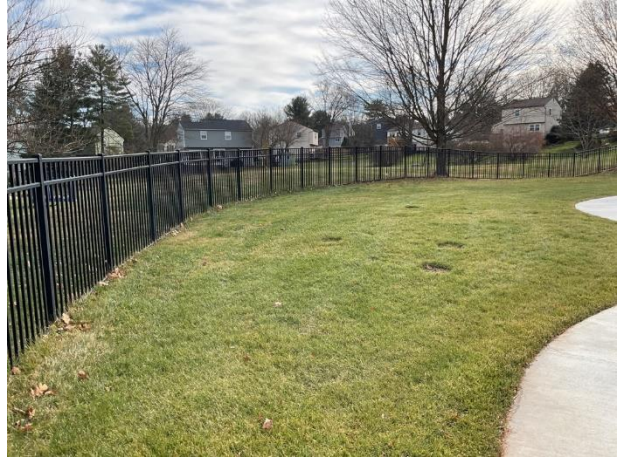
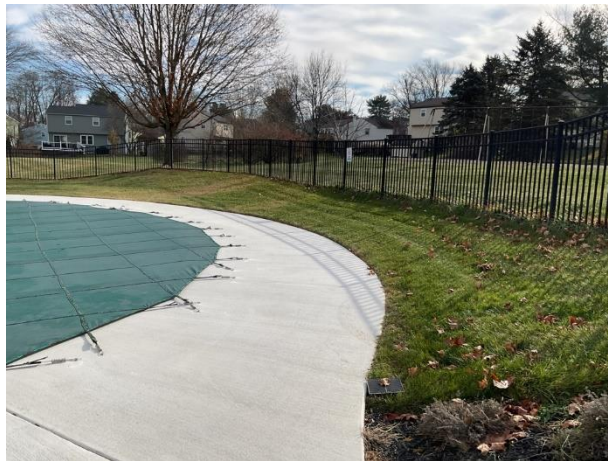
**Condition:** Good to fair overall

**Aluminum pool fence**

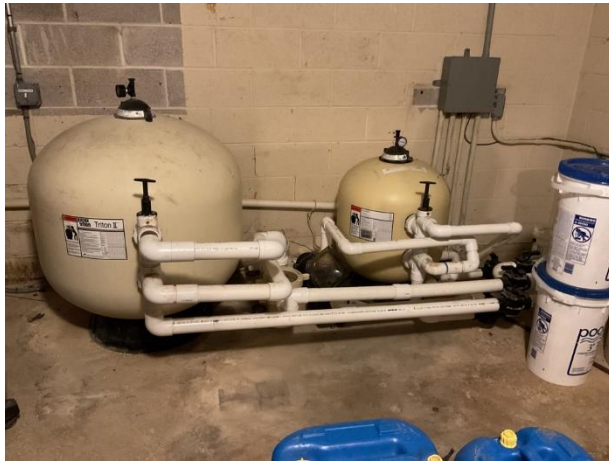
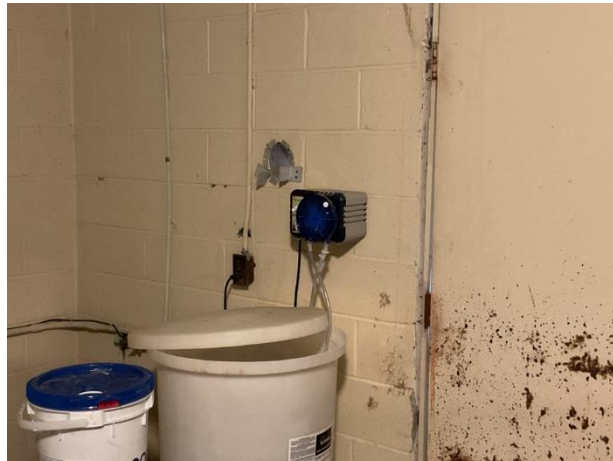
**Condition:** Reported satisfactory overall

Pool mechanical equipment

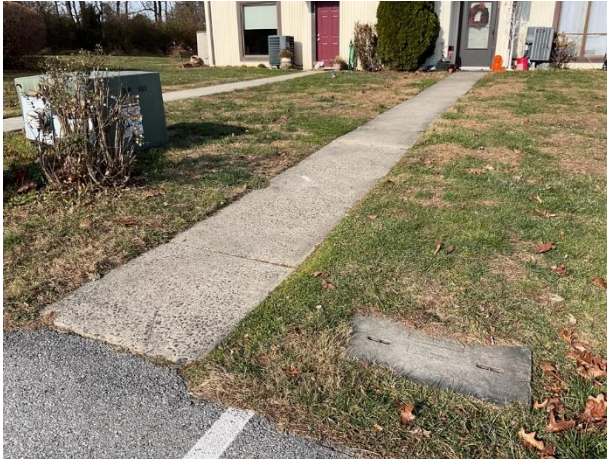
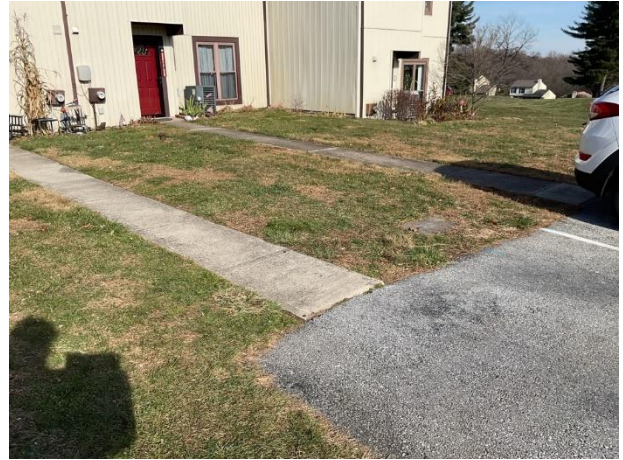
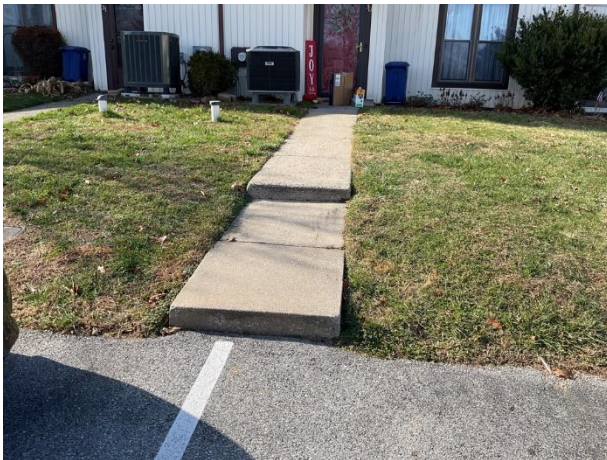
**Condition:** Fair overall with cracks and deterioration evident

**Concrete sidewalk**

**Expenditure Detail Notes:** Expenditure timing and costs are depicted in the **Reserve Expenditures** table in Section 3. We estimate that up to 2,040 square feet of concrete sidewalks, or sixty percent (60%) of the total, will require replacement during the next 30 years.

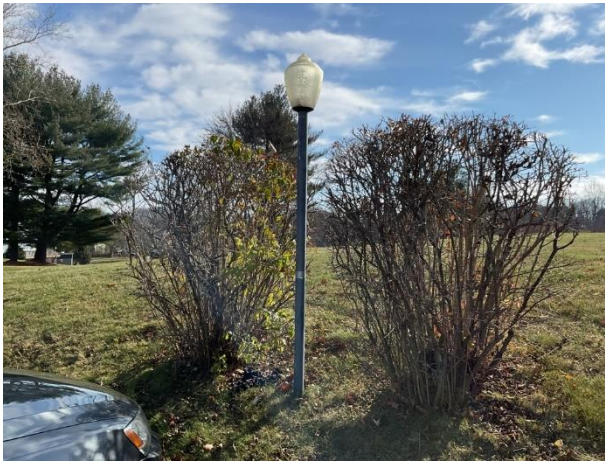
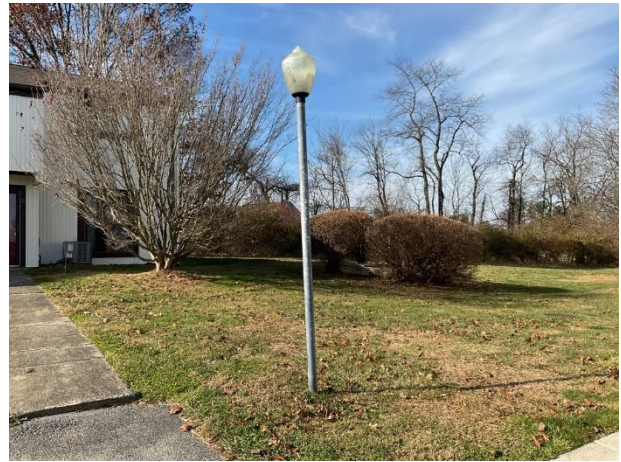
- Hastings Court: three metal poles with fixtures; unknown age; fair to poor overall condition with deterioration evident
- Wyndham Court: seven metal poles with fixtures; replaced with the last 13 years; good to fair overall condition

Light pole and fixture

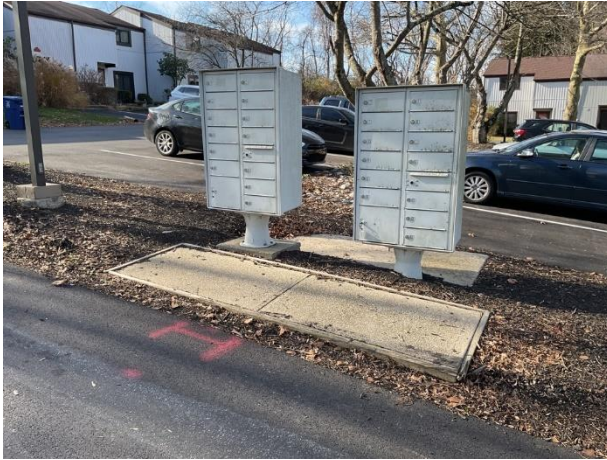
**Condition:** Fair overall with rust and deterioration evident

**Mailbox stations**

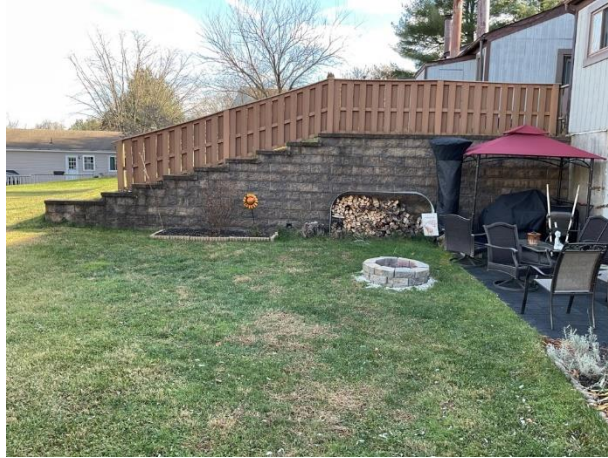
**Condition:** Good to fair overall

**Masonry retaining wall**

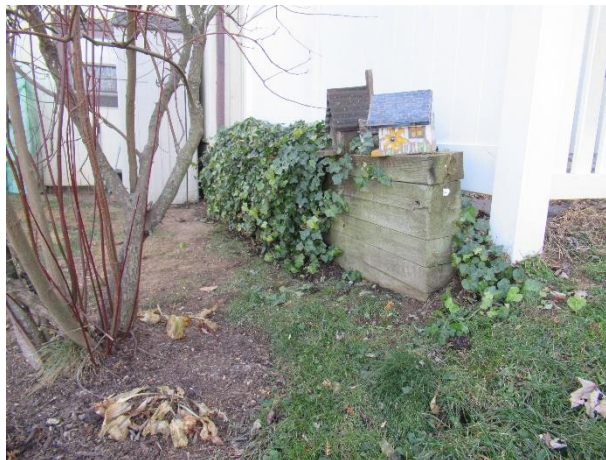
**History and Condition:** Approximately fifty percent (50%), or 70 square feet, of timber retaining walls were recently replaced and are in good overall condition. In addition, the retaining fifty percent (50%) of the walls are original and in fair overall condition.

Timber retaining wall

**Expenditure Detail Notes:** Expenditure timing and costs are depicted in the **Reserve Expenditures** table in Section 3. Our near term cost estimate includes for the replacement of the remaining 50% of original retaining walls.
